February 2004
Exterior Building Conditions Inspection Report:
Laurel Train Station Building
Laurel, DE

Philip E. Franks
Hurley-Franks & Associates
HFA Project # 2003.010

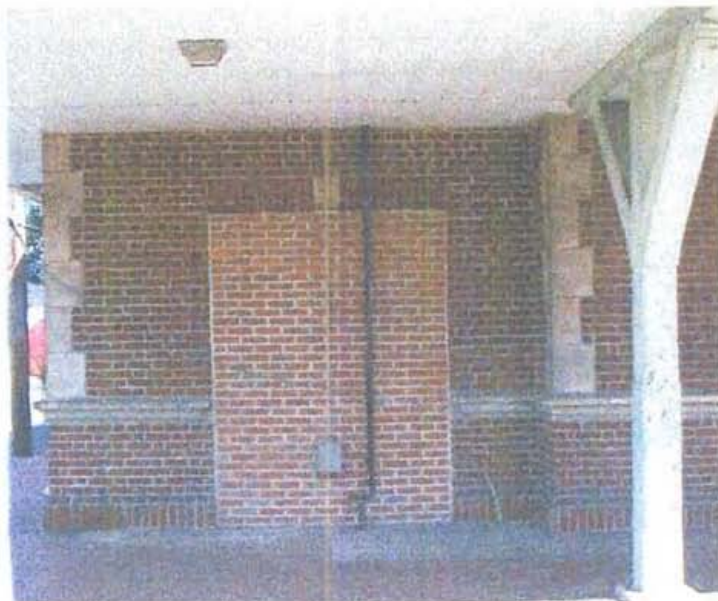
Photo-1

Most of the exterior brick masonry walls appear to be original and to be in excellent condition with little or no damage to the masonry or mortar joints. On both the platform side and the side opposite to the platform, the original openings for the freight doors have been filled with exposed brick on concrete masonry. The platform side is completely filled with new masonry. The opposite side has a single wood door to match the other raised panel wood doors on the station. (See Photos 1 & 2)

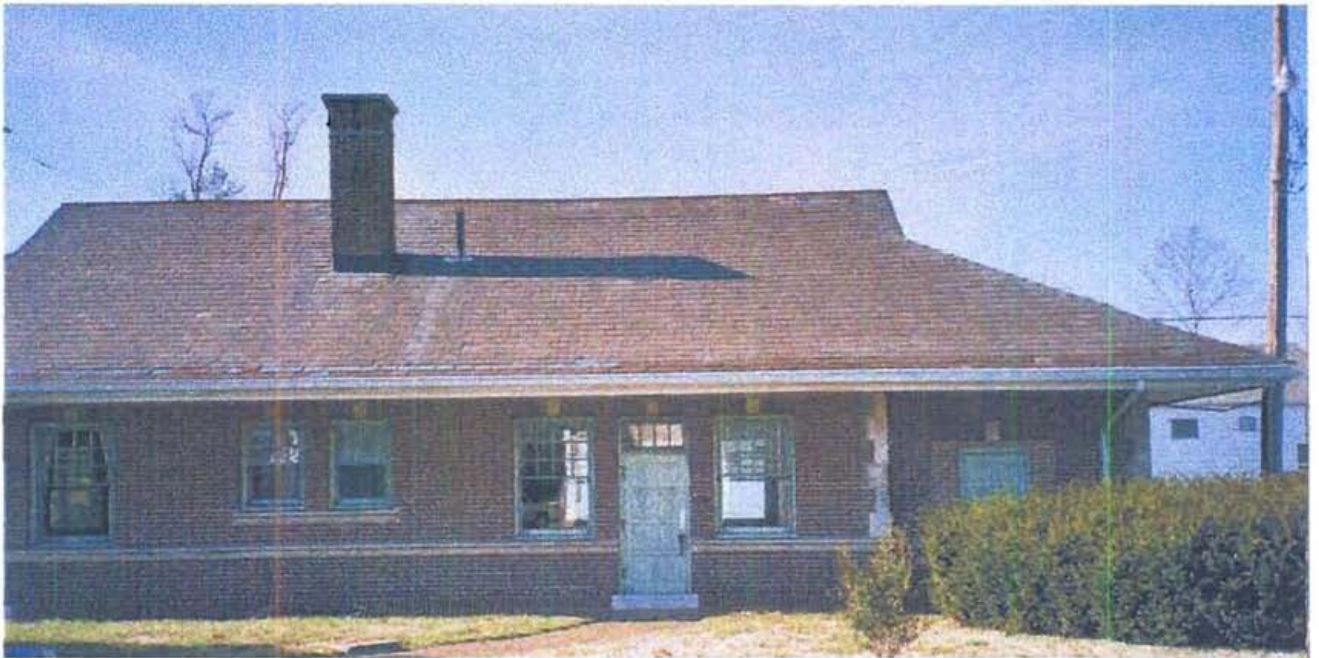
Photo-3

The exterior masonry wall has a continuous stone belt course and ledge located at the windowsill elevation. The building also has stone quoins at each of the outside corners and stone keystones above each door and window opening. This stone appears to be in excellent condition and only in need of cleaning. Likewise, the existing stone thresholds are intact and, although worn, are only in need of cleaning. *(See Photos 3 & 4)*

The general appearance of the exterior masonry could be improved with a good power washing. Any such effort should be accompanied by proper protection against driving water into the joints between wood and masonry, such as door and window frames and up into the bead board ceiling of the exterior roof overhang.

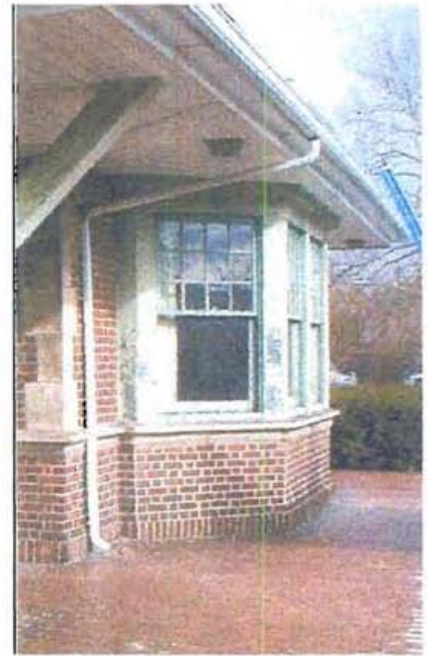
Photo-4

All wood windows and frames and doors and frames are in good condition. However, all are in serious need of maintenance. The bay window frame and window units facing the southeast are in the greatest need. They appear to receive more direct exposure to sun and rain than do any of the other windows most of which are protected by the overhanging roof. All of the bay window sashes have significant weathering of all wood frames and sills and glass glazing. These bay windows should have all of the loose glazing grout removed and replaced.

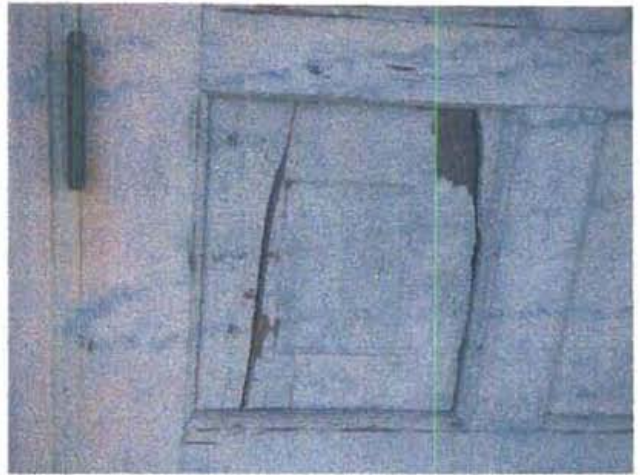
Photo-7

Of the five existing wood doors, only one appears to require any significant repair. In this single door, one of the raised panels is damaged (cracked or split through). It does not appear to be affecting the structural integrity of the door and seems to be repairable. (See Photo 7)

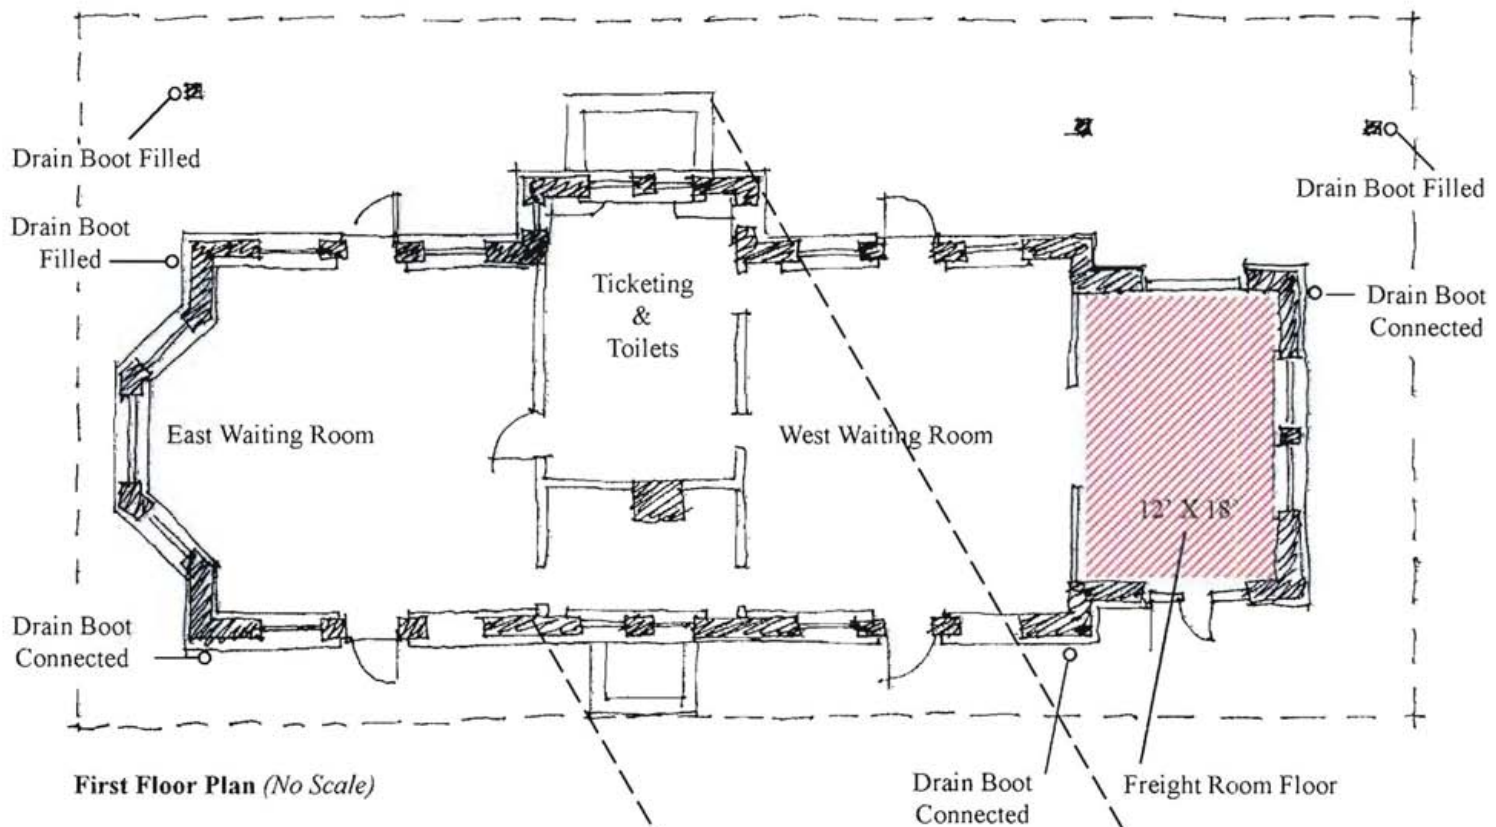
First Floor Plan (No Scale)

The original floor elevation of the Freight Room was at the platform level, approximately 7-8" below the elevation of the First Floor. Sometime in the past the original Freight Room floor level was raised, presumably through the use on wood sleepers and floor decking. This floor elevation now matches the elevation of the rest of the First Floor. However, the floor surface is soft and spongy. Given the previous termite infestation and damage, I suspect termites or water damage to this flooring system and suggest the complete replacement of both the sleeper joists and the floor decking.

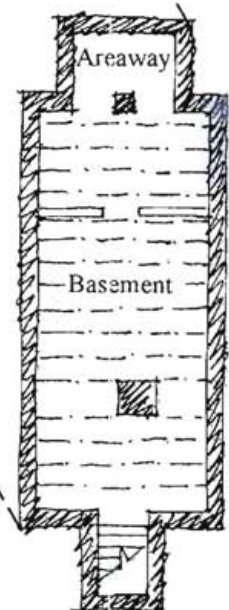
Basement Plan (No Scale)

As result of visual inspection it appears that the termites gained access to the interior of the Station areas by way of the exposed ends of wood joists located in the Basement ceiling. These floor joists are pocketed into the masonry foundation walls, walls that form the perimeter of the small Basement area. No destructive investigations were performed to seek to expose the ends of any joists. It appears that most, if not all, of the wood floor joists have been damaged by termites. There is also no visual evidence

that the infestation was chemically treated. Normally one would see evidence of drilled probes performed to confirm infestation and to determine the degree of damage to the wood members. None was noted. Also chemically treated structures generally have 'date of treatment' chalked on beams and joist. None was noted. Laurel Superintendent of Public Works, Danny McCumber, was asked if he was aware of any chemical treatment of the building. He was not aware of any.

Without additional testing of the wood joists it is not possible to conclude that they are sound and satisfactory. I believe a number are not suited to supporting any significant new and additional floor loads. In addition, I believe that without a chemical treatment of these joists and the removal of the joists ends from their pockets in the Basement masonry walls, the chances are great that they will again provide a pathway for the re-infestation of the Station. All of these joists should have their pocketed ends cut off and removed from their wall pockets. The pockets should be filled with grout to prevent the entry of termites.

A new steel angle ledge should be bolted to the masonry wall to support the original wood joists. In addition each joist should be sistered on both sides with new 2X10 pressure treated lumber.

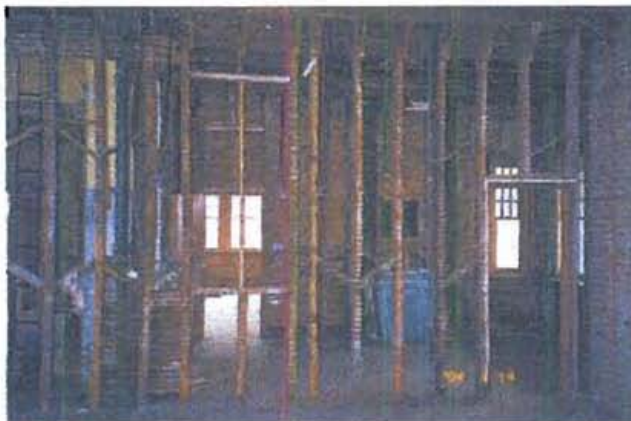
Photo-8

There is significant termite damage to the interior wood studs located in the center of the building. Some wood studs show damage as high as the ceiling (10-12'). However, given the large size of the original wood studs and the minimal load currently bearing on these studs I do not believe they require replacement. However, once work proceeds on the interior, the studs that remain should be 'sistered' and left in place.

The Station should be treated for termites and a protective barrier placed around its perimeter. This treatment should include pressure injection of chemicals into the remaining ends of the floor joists.

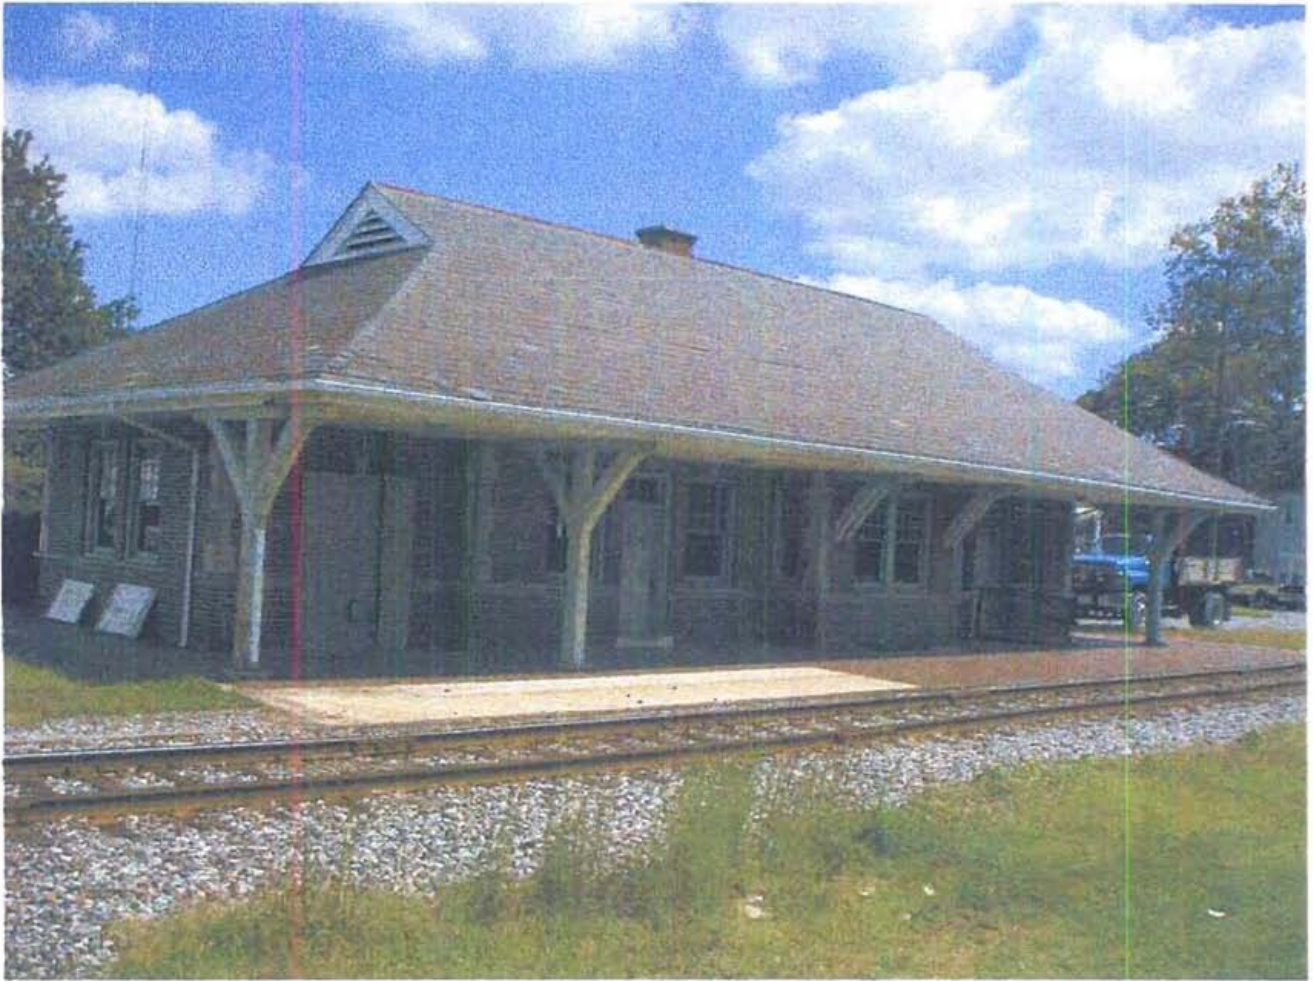
Photo-11

The brick paving surrounding the station area is in fair condition. A section of the platform pavers have been removed and paved with concrete. Otherwise the brick pavers appear to be stable and only in need of minor grouting, and the removal of storm drains that discharge directly onto the concrete and brick surfaces.
(See Photo 11)

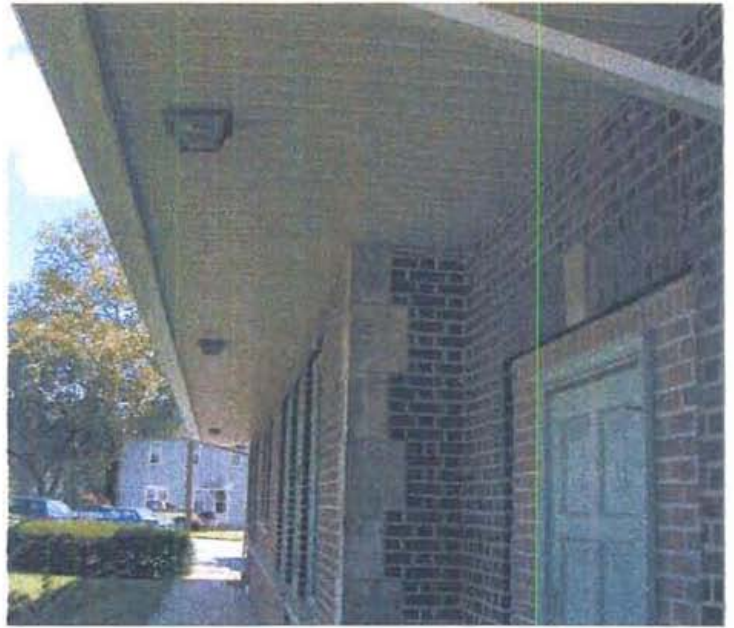
Photo-16

There are a number of exterior light fixtures that are mounted on the surface of the soffit. Most of these fixtures appear to be in serviceable condition, requiring only new bulbs and electrical power. (See Photos 16 & 17)

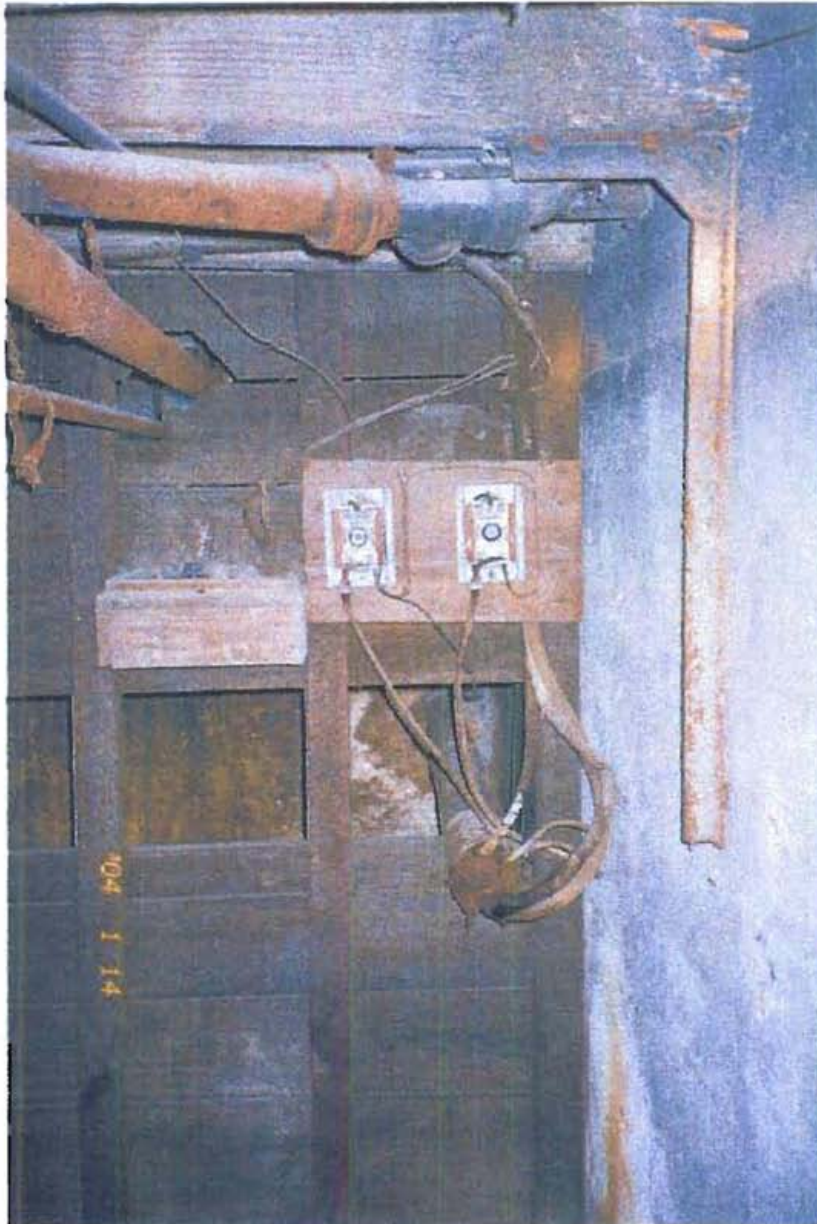
Photo-18

- Electric Power: It appears that the original electrical power supply lines came through a 4" C.I. pipe extending from the platform wall in the basement. This does not appear to have been an active source of electrical power for some many years. In fact this C.I. pipe may be part of the source of water in the Basement since it was observed leaking water on 01/14/04. (See Photo 18)

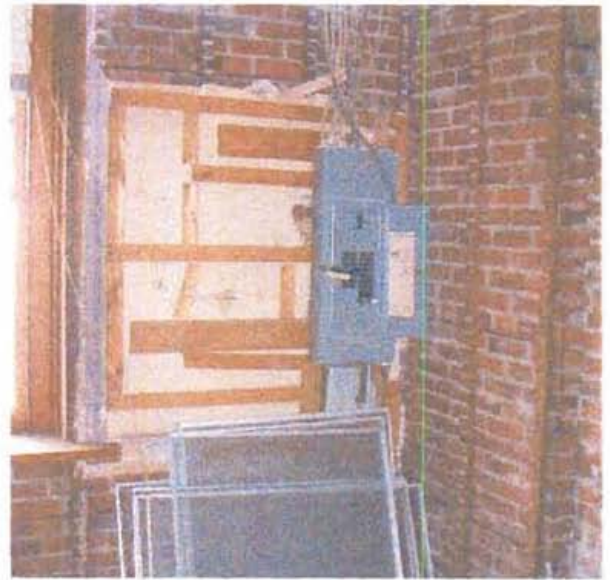
Photo-19

The most recent electrical power supply (disconnected) seems to have come from a power pole located outside the north corner of the old Freight Room. There is a main power drop to the Station into a main electrical panel box currently located on the north inside corner wall of the old Freight Room.

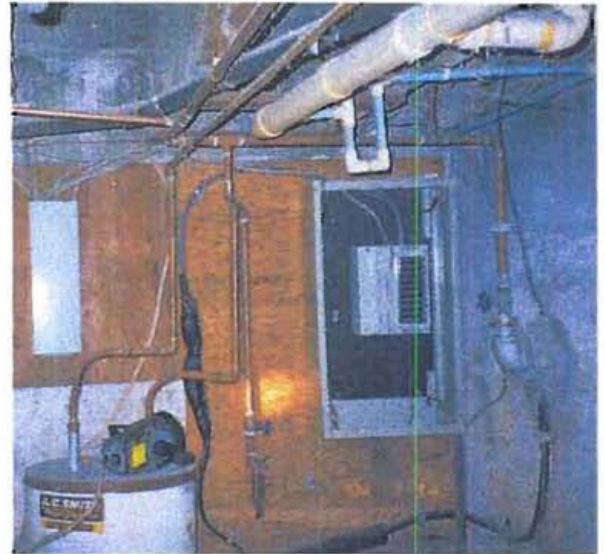
Photo-20

- Telephone: Telephone and communication lines extend from the east wall of the Basement, on the left side (facing) of the stair opening. *(See Photo 20)*

- Water: Water service comes into the Basement through the east wall of the Basement, on the left side (facing) of the stairway. *(See Photo 20)*

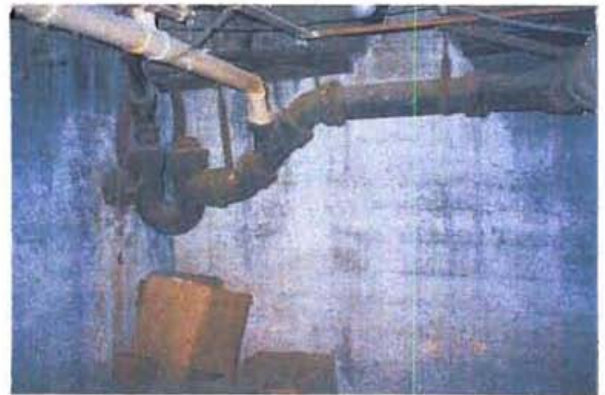
Photo-21

- Sanitary Sewer System: Sanitary sewer lines, 4" diameter, extend into the Basement through the east wall of the Basement, on the right side (facing) of the stairway. *(See Photo 21)*

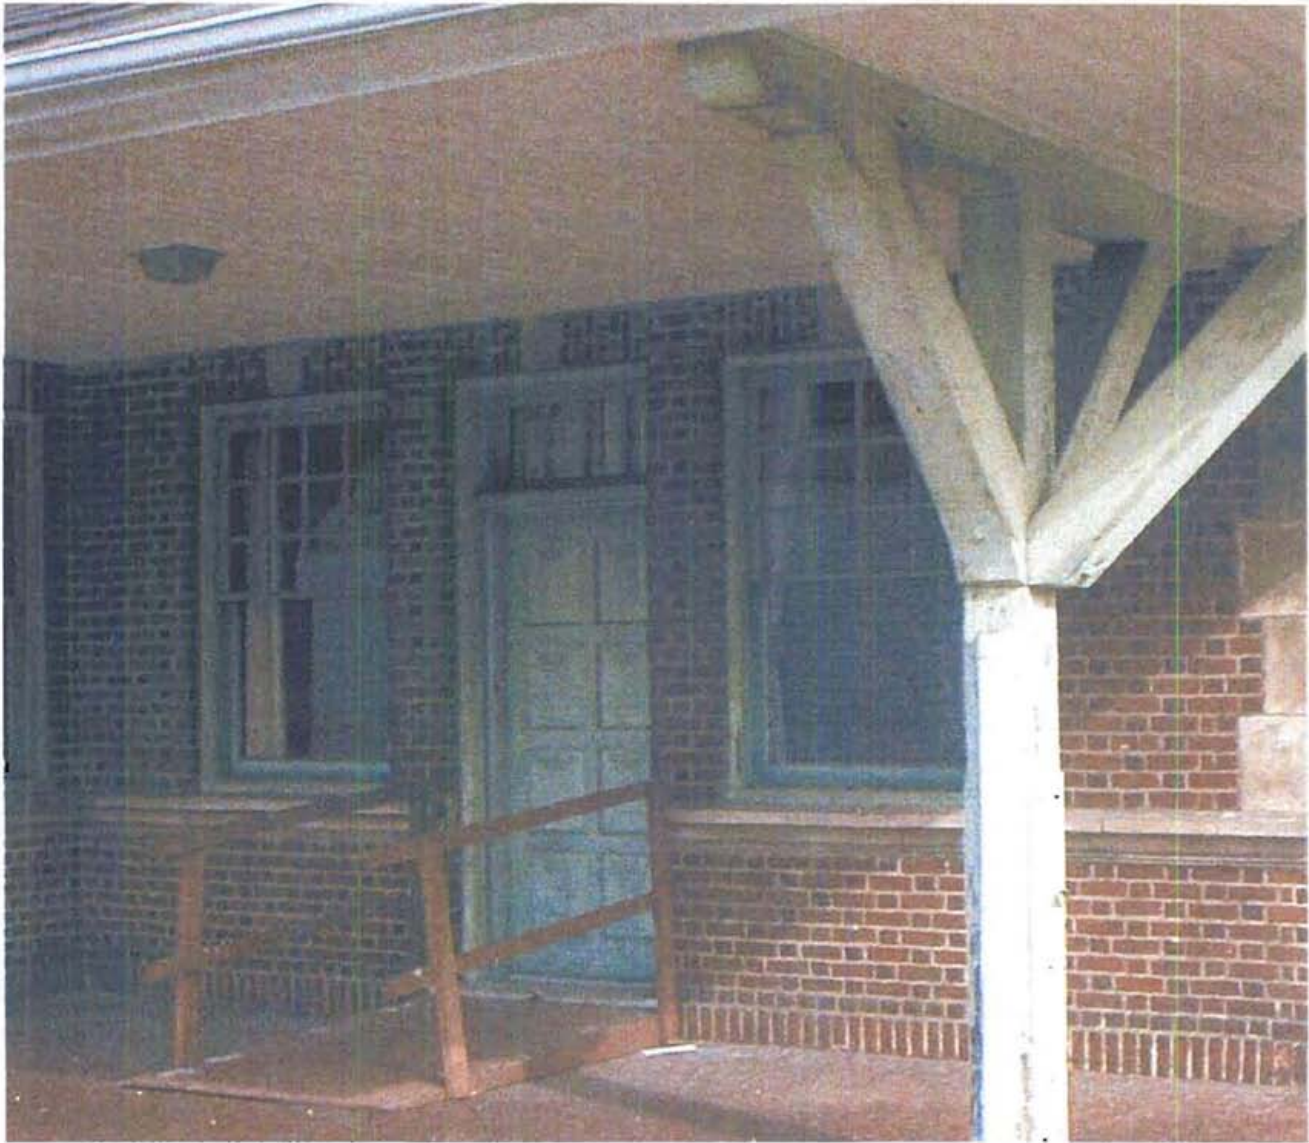
Photo-22

The first floor is approximately 7" above the surrounding exterior brick paving. A temporary wood ramp and railing provided handicapped access to the building when it was previously used as the Town Hall. New ADA compliant ramps and hand railings will have to be constructed.
